United States
Circuit Court of Appeals
For the Ninth Circuit.

UNITED STATES OF AMERICA,
Appellant,

J. LESLIE MORRIS COMPANY, INC., a cor-
poration,
Appellee.

Transcript of Record
(Plaintiff's Exhibits 1 to 32)

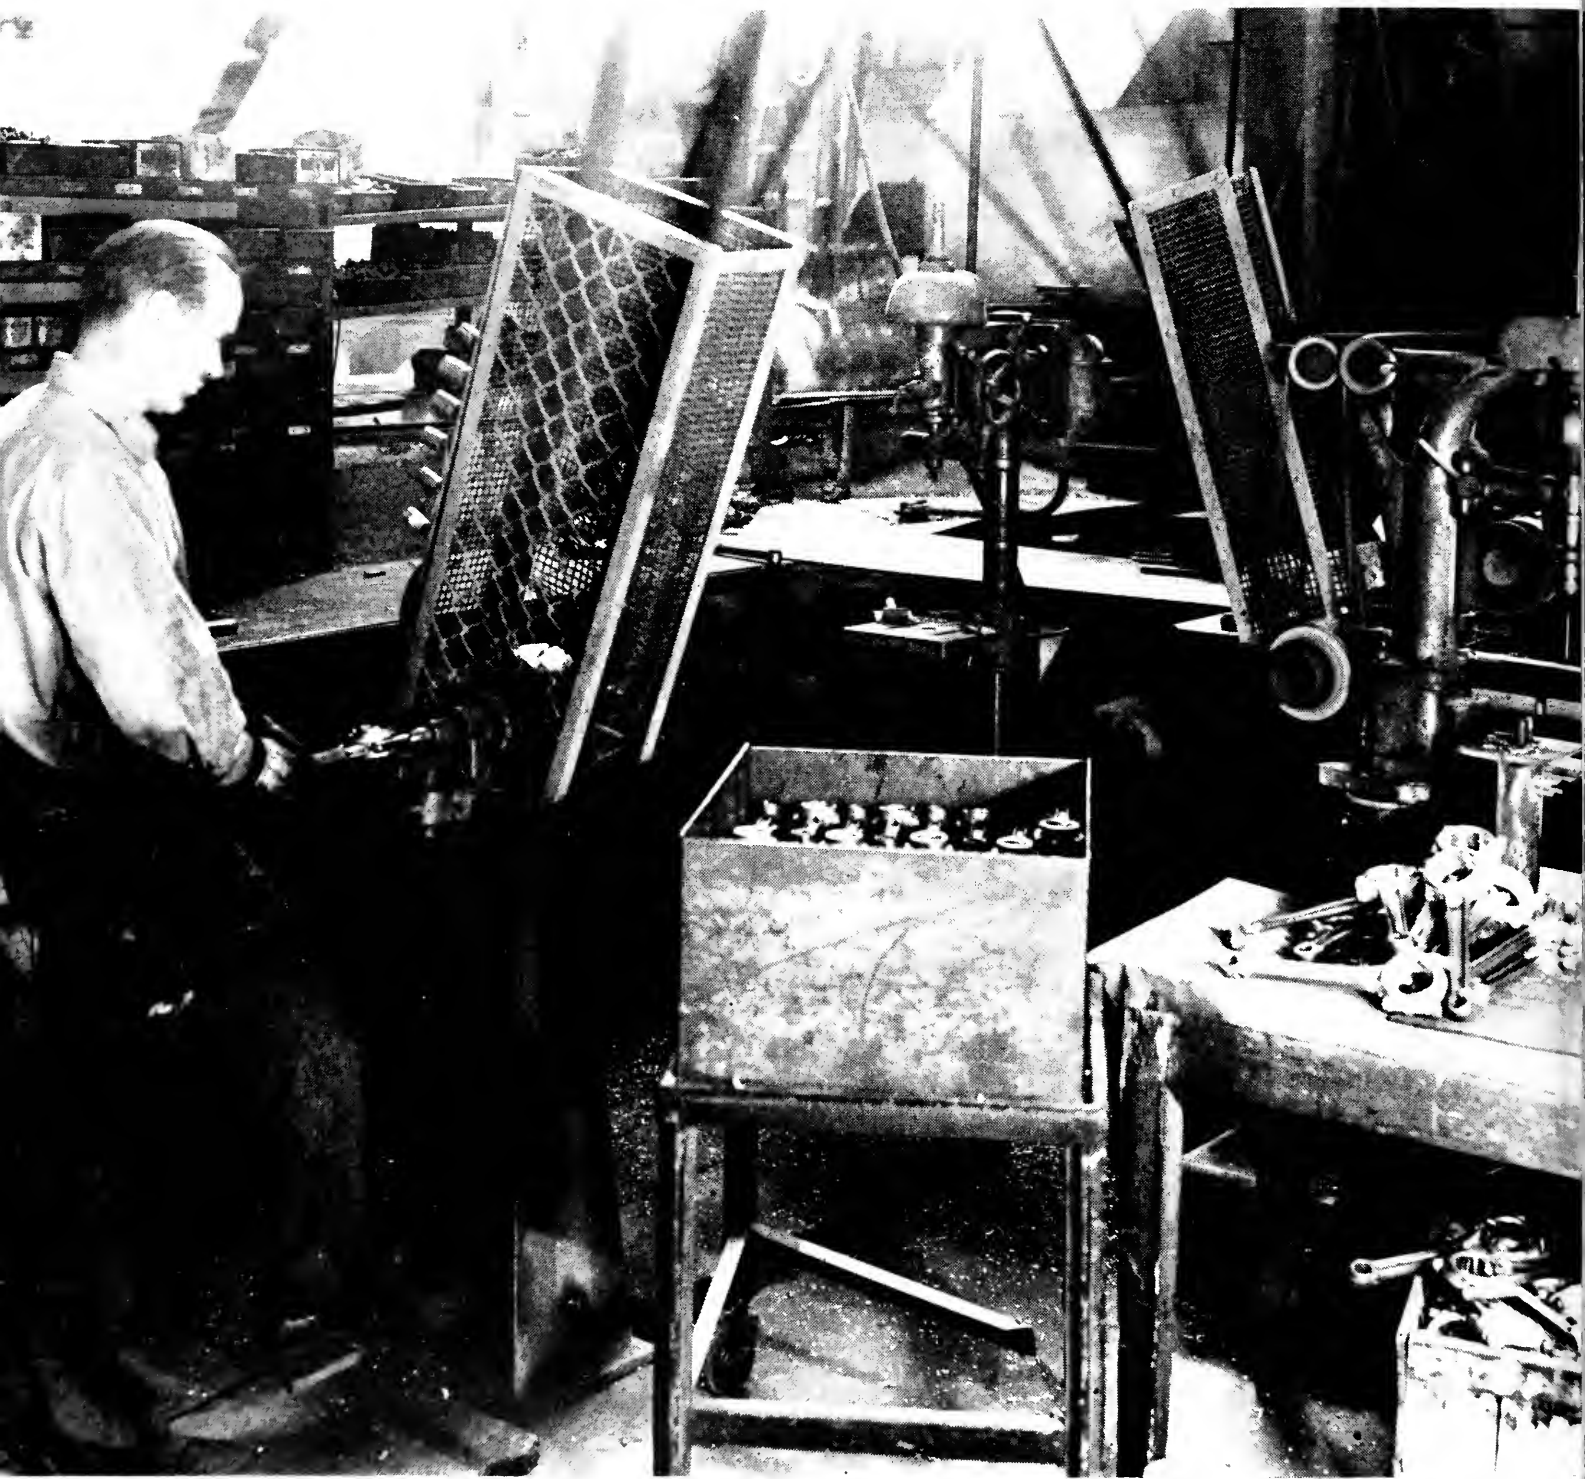
PLAINTIFF'S EXHIBIT No. 17

The cap is replaced on the rod using the original bolts and nuts, the removal of which was described in Picture 5. A power driven socket wrench is used in performing this operation.

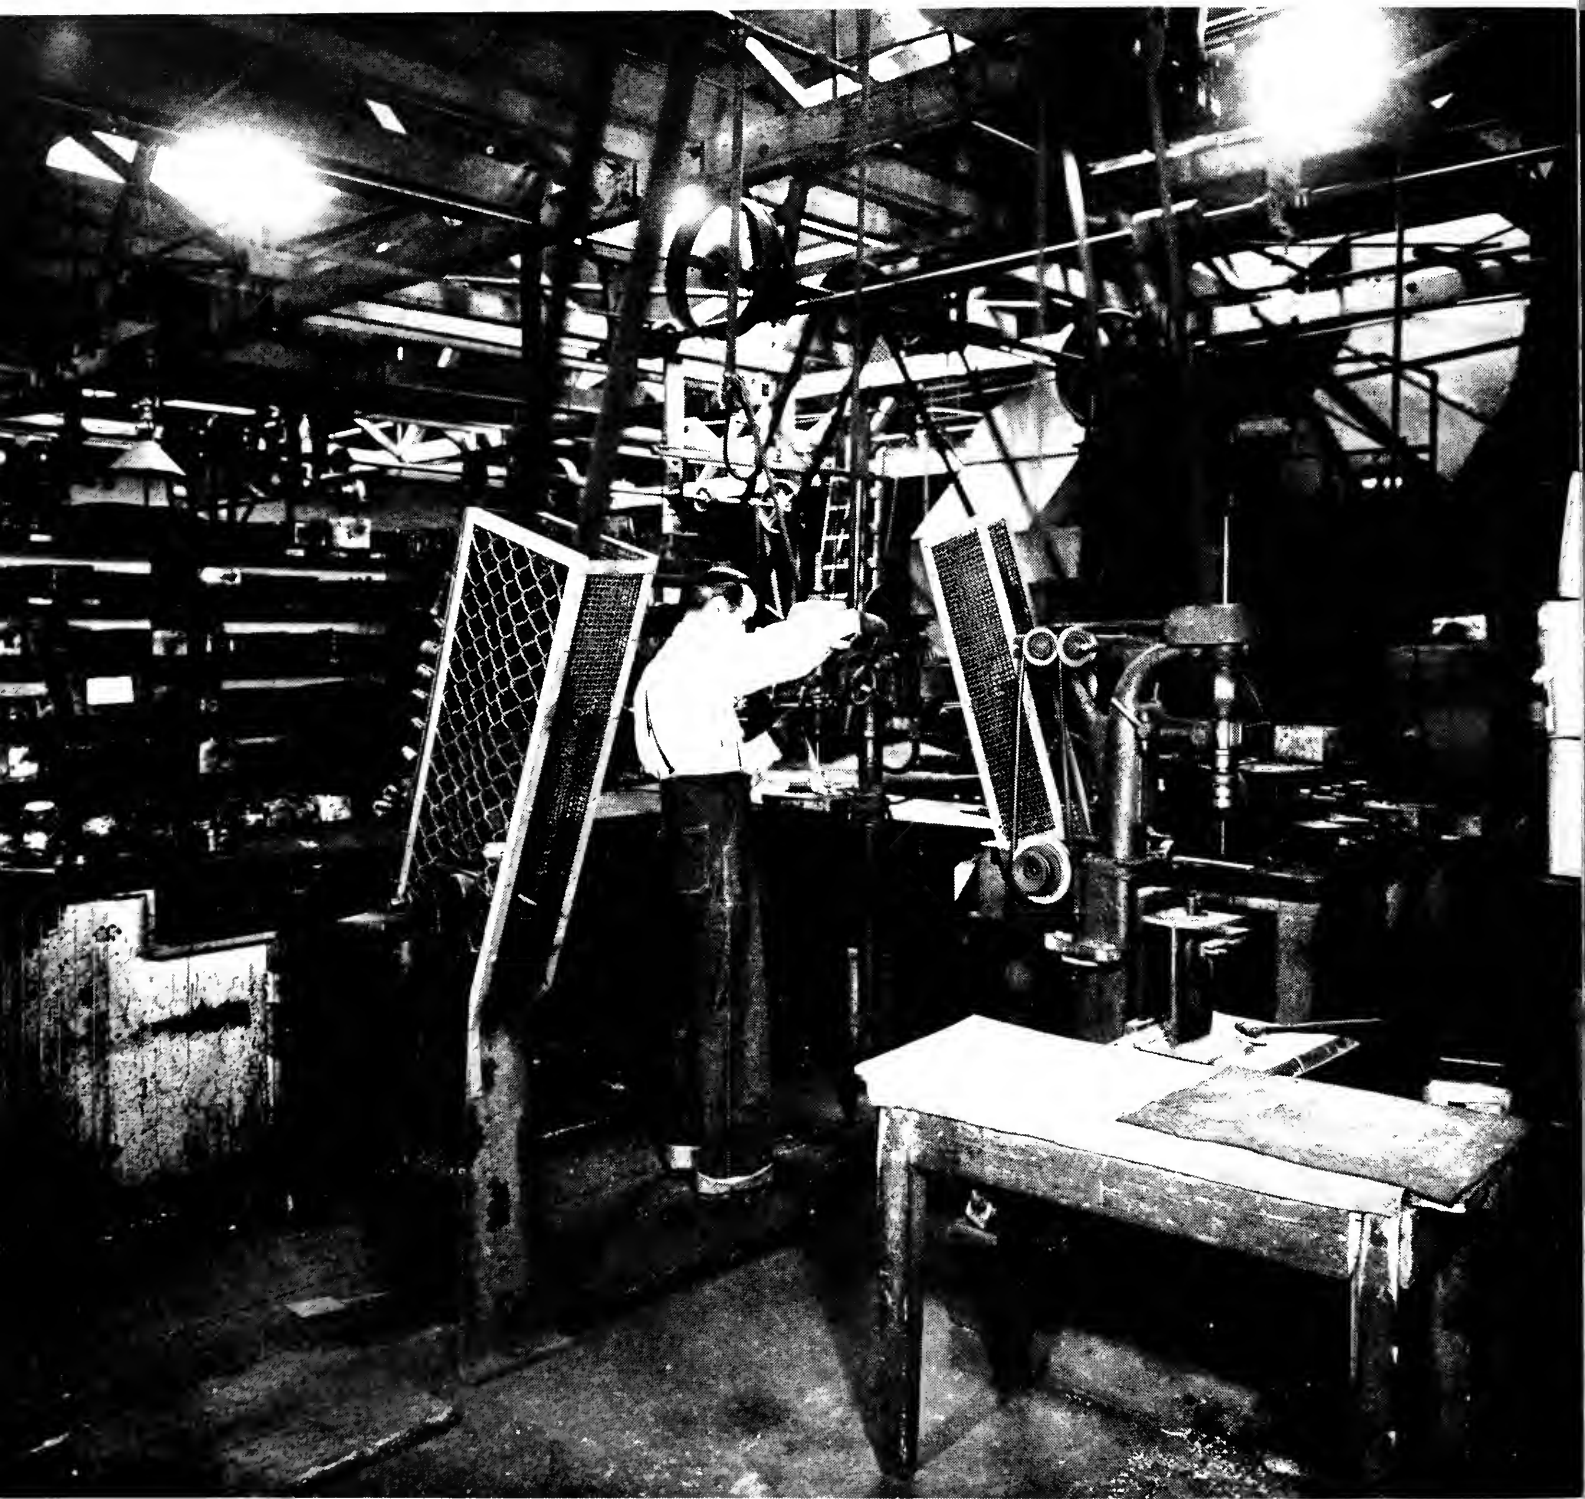
PLAINTIFF'S EXHIBIT No. 18

The operator cleans out the oil holes by use of a drill press as shown in this picture.

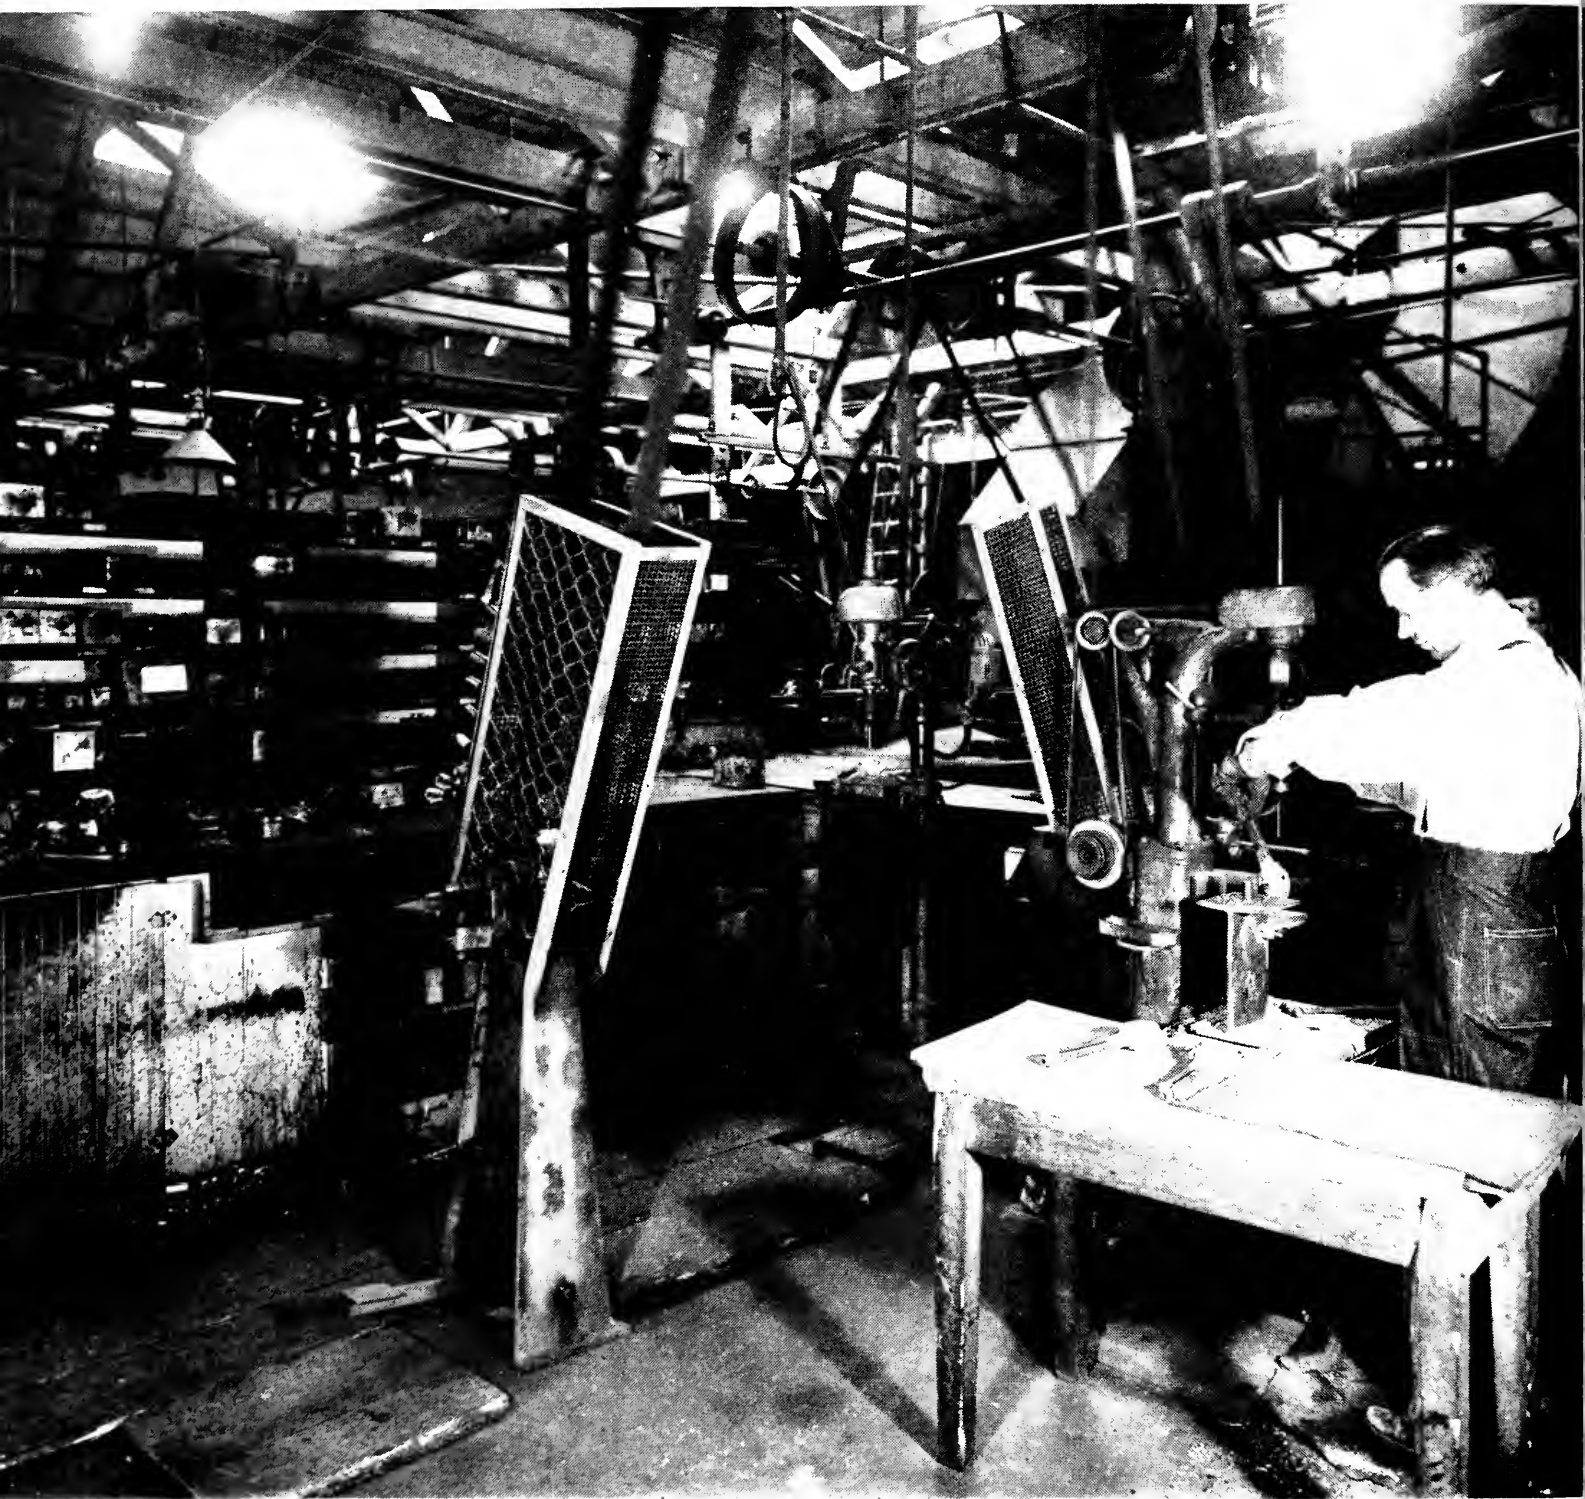
PLAINTIFF'S EXHIBIT No. 19

The oil holes are not always the same size. Accordingly, the operator uses a second drill press with a larger drill to perform the same operation shown in Picture 18. This removes the necessity for frequently changing drills.

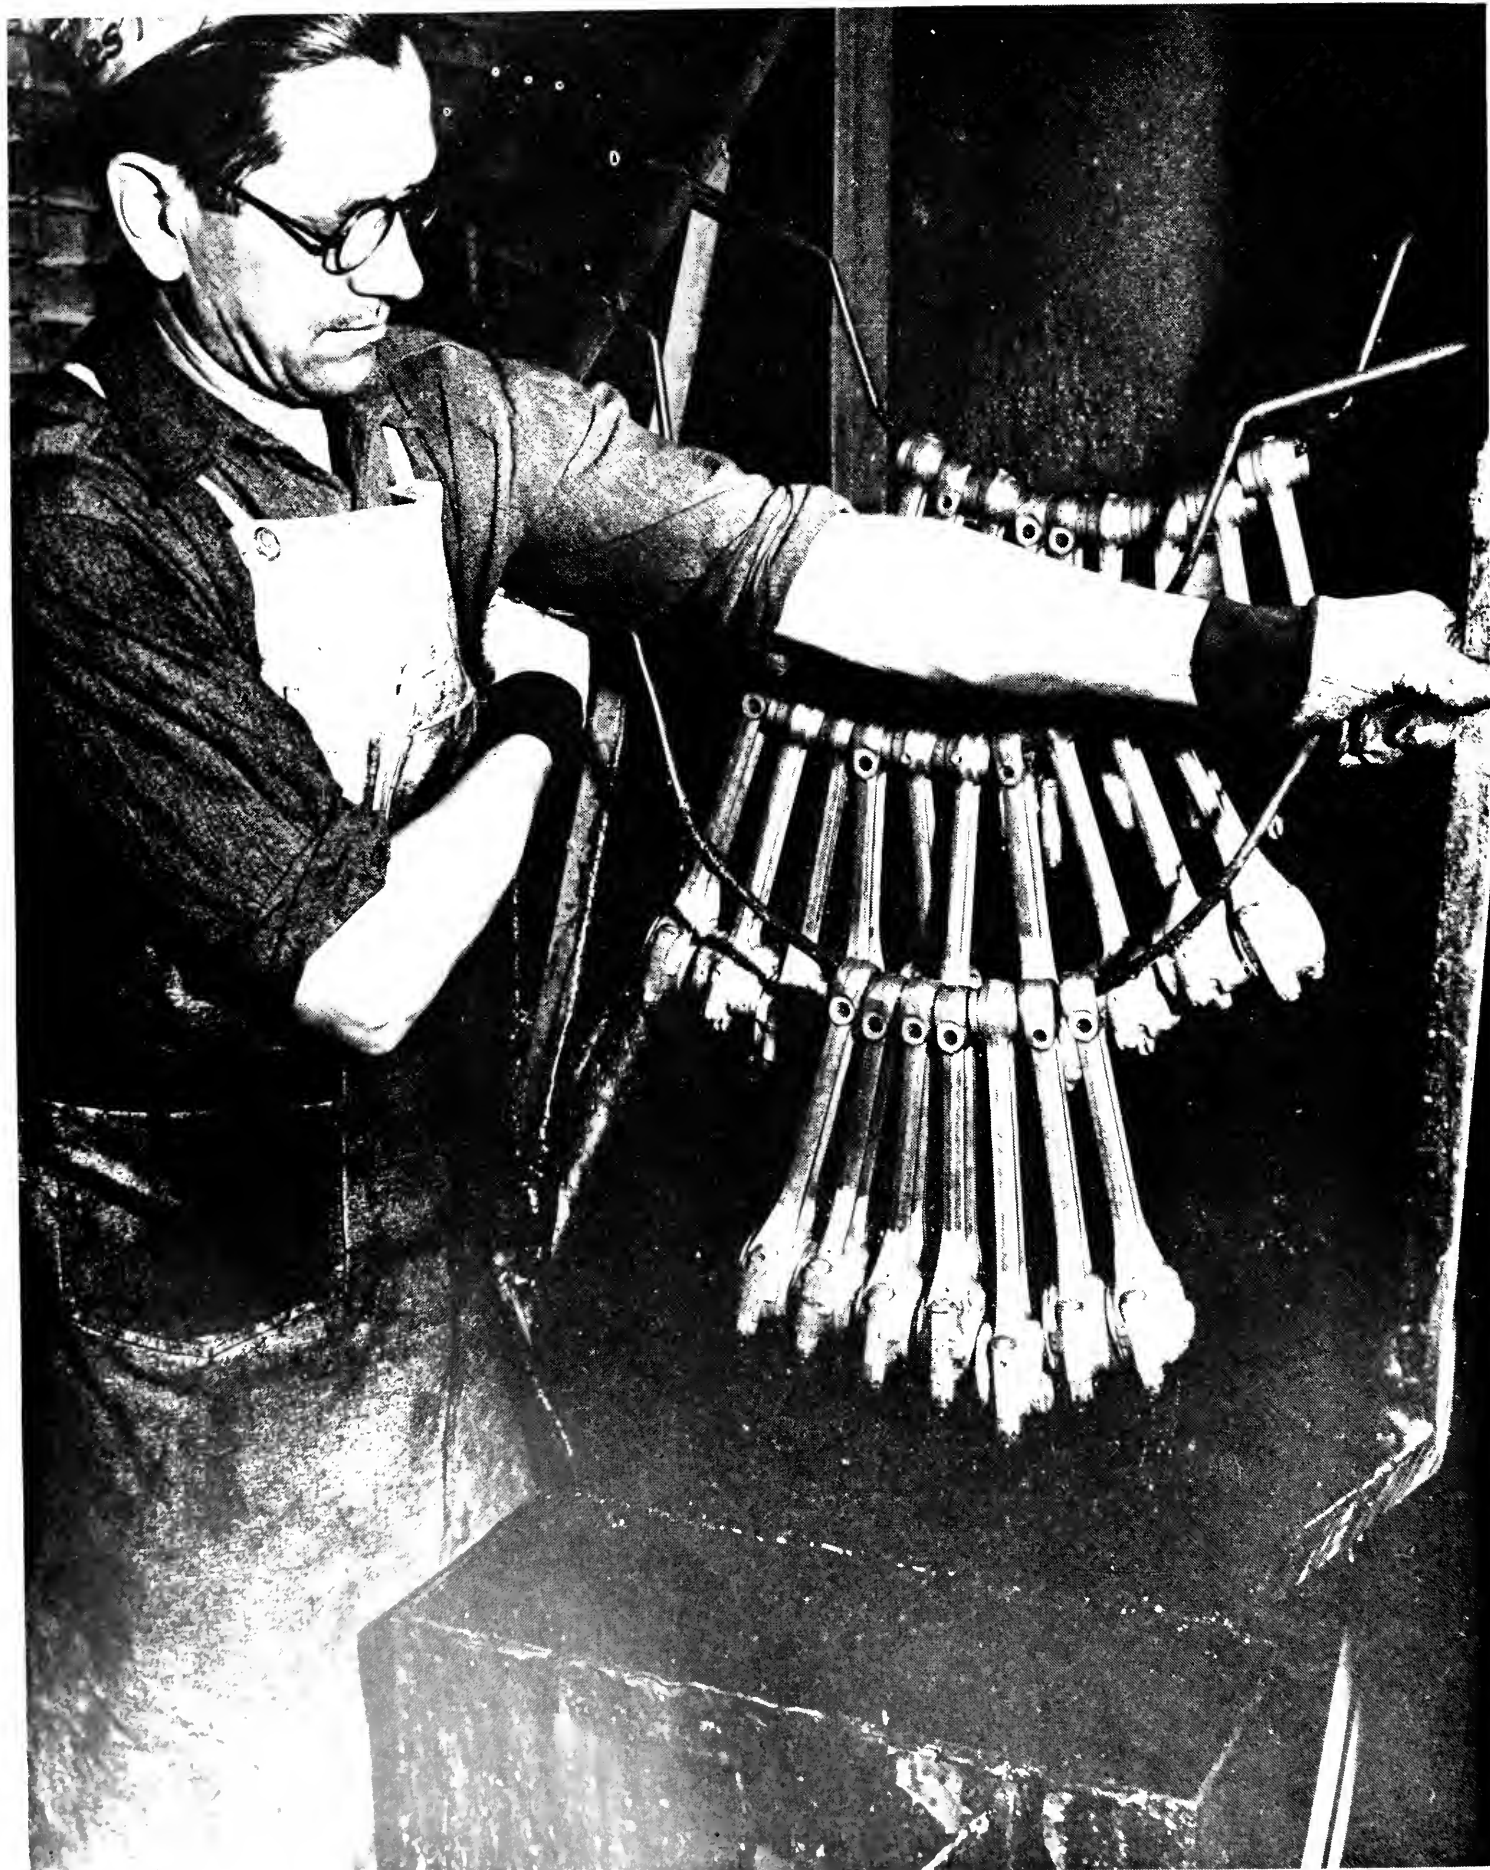
PLAINTIFF'S EXHIBIT No. 20

The rods are now dipped in a rust preventative and are then hung on a rack to dry,—as shown in above picture.

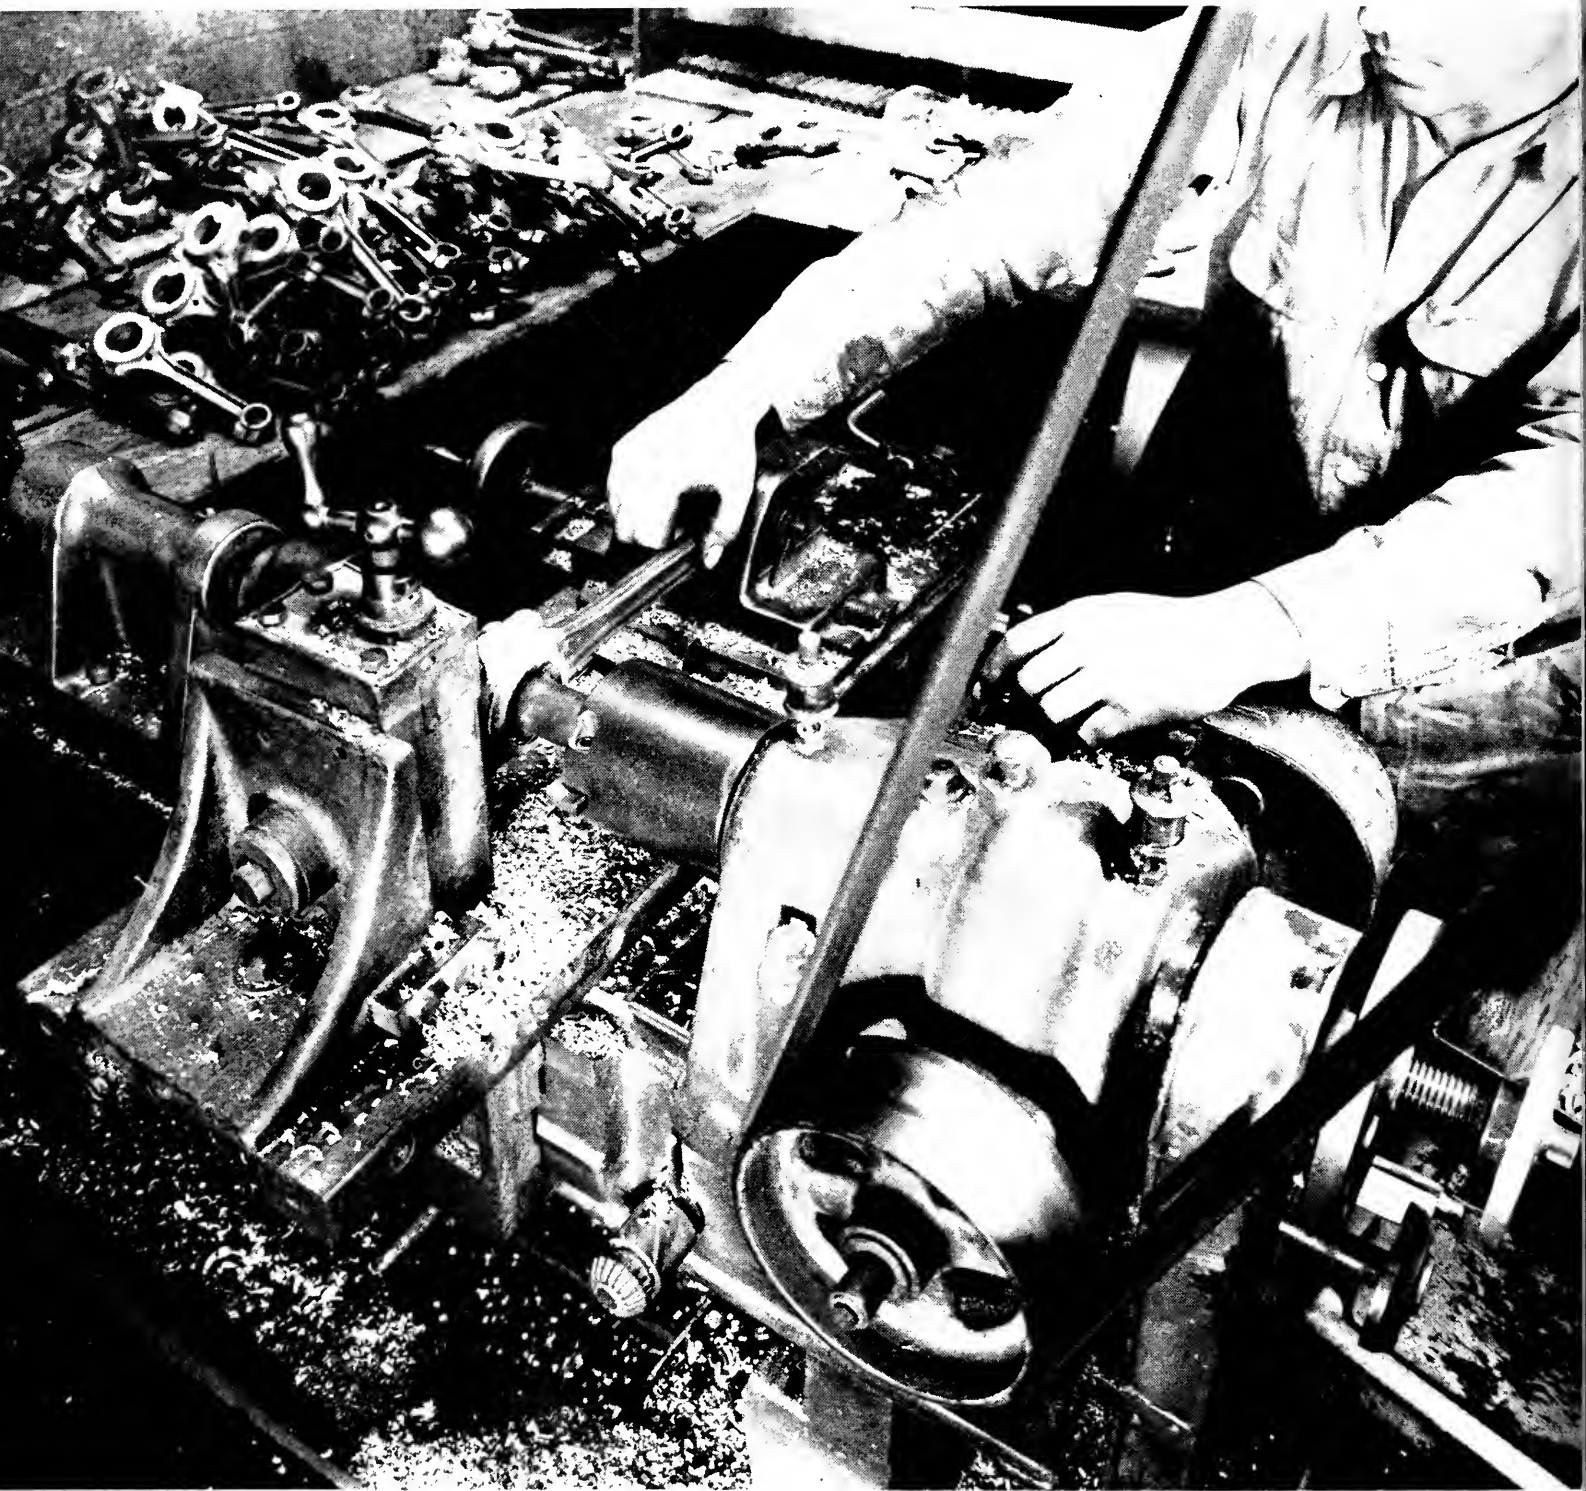
PLAINTIFF'S EXHIBIT No. 21

The rod is now placed in a lathe and the babbitt is bored, faced and chamfered. The latter two operations finishes the bearing to standard width.

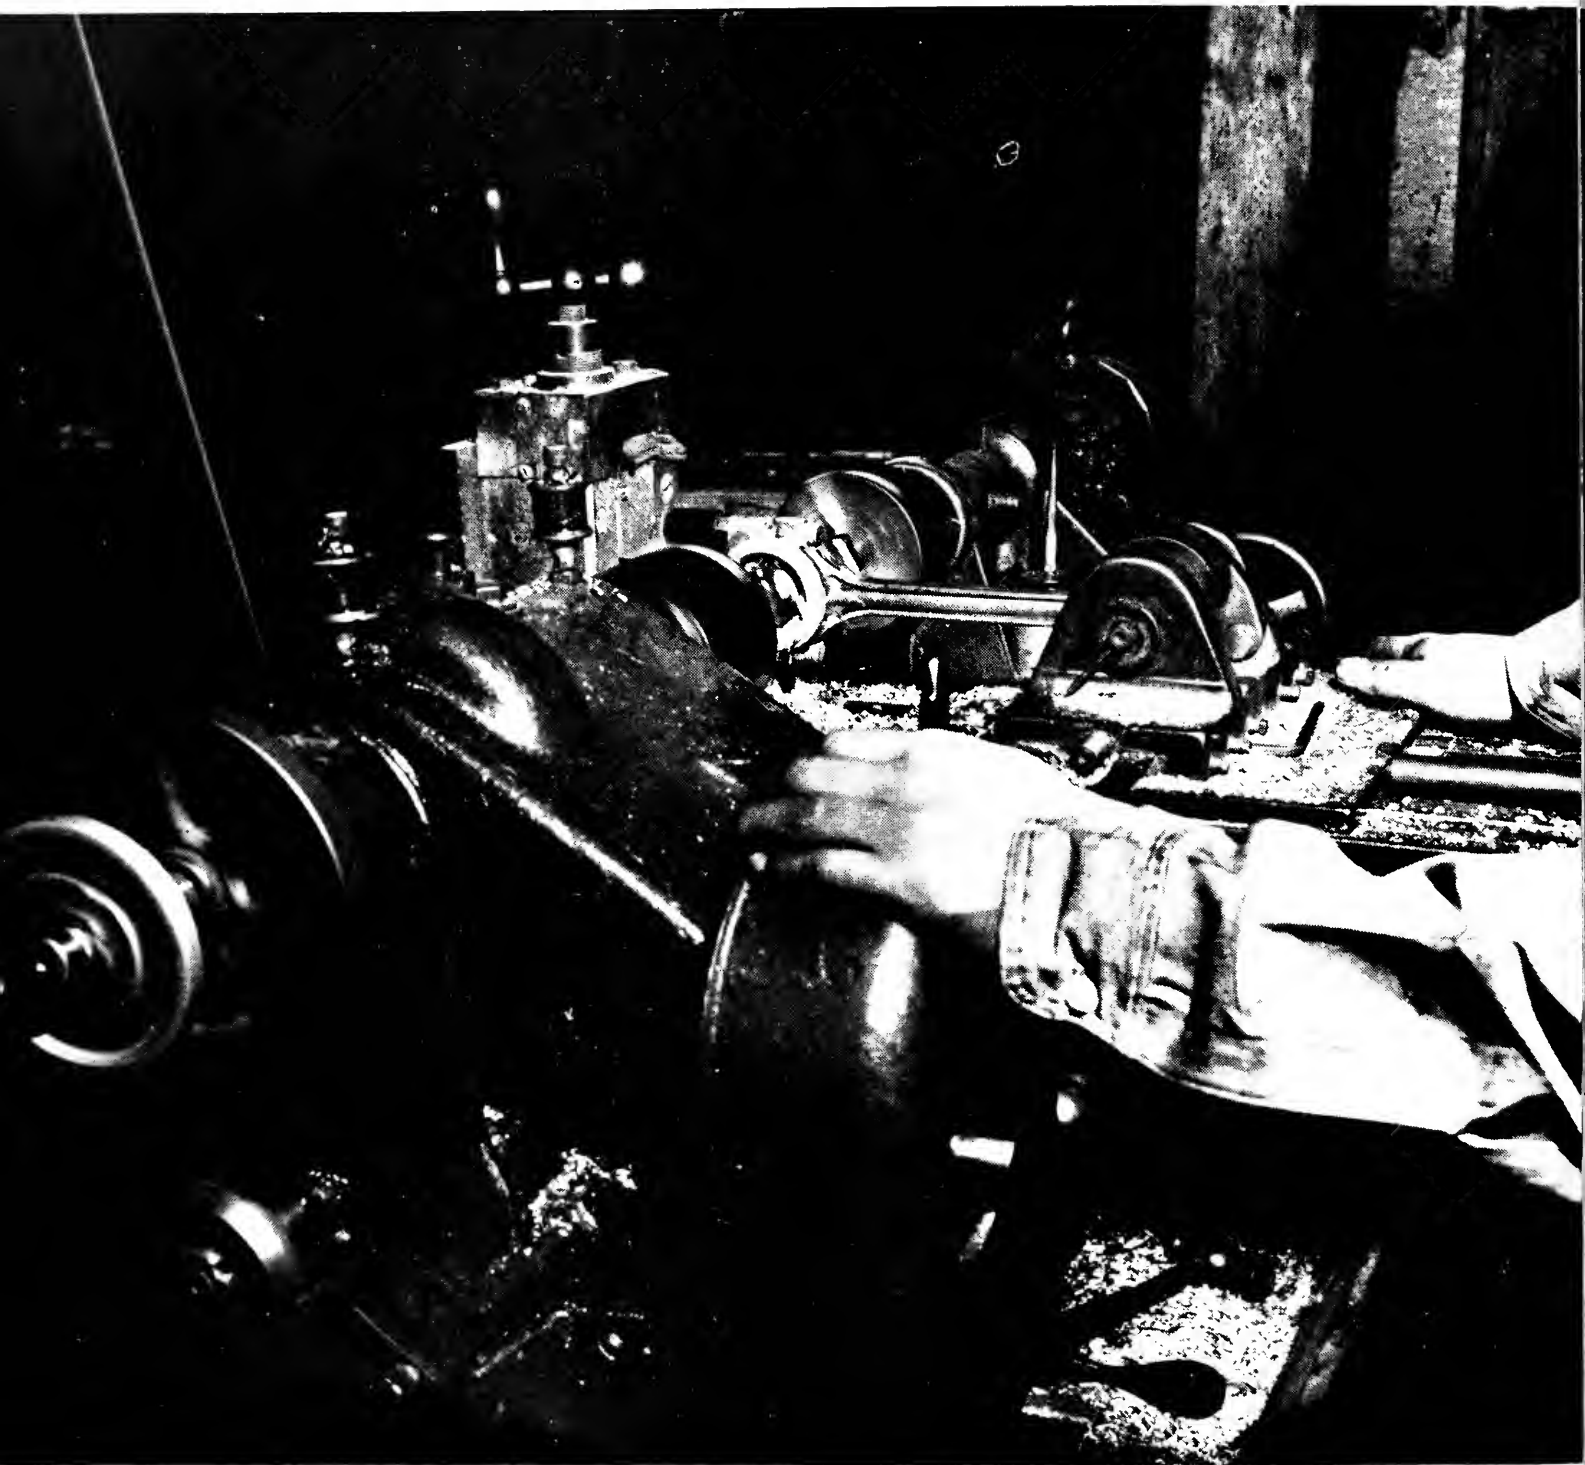
PLAINTIFF'S EXHIBIT No. 22

The lathe used in the above picture is identical with the one shown in Picture 21, however it is used for finishing babbitt bearings to special undersizes as ordered by the customer. About 20% of the connecting rods rebabbitted by the plaintiff are bored to special undersizes for the reason that the crankshafts of the automobiles in which they are to be placed have been reground in order to correct for the wear which has resulted from long operation.

The lathe used in the above picture is identical with the one shown in Picture 21, however it is used for finishing babbitt bearings to special undersizes as ordered by the customer. About 20% of the connecting rods rebabbitted by the plaintiff are bored to special undersizes for the reason that the crankshafts of the automobiles in which they are to be placed have been reground in order to correct for the wear which has resulted from long operation.

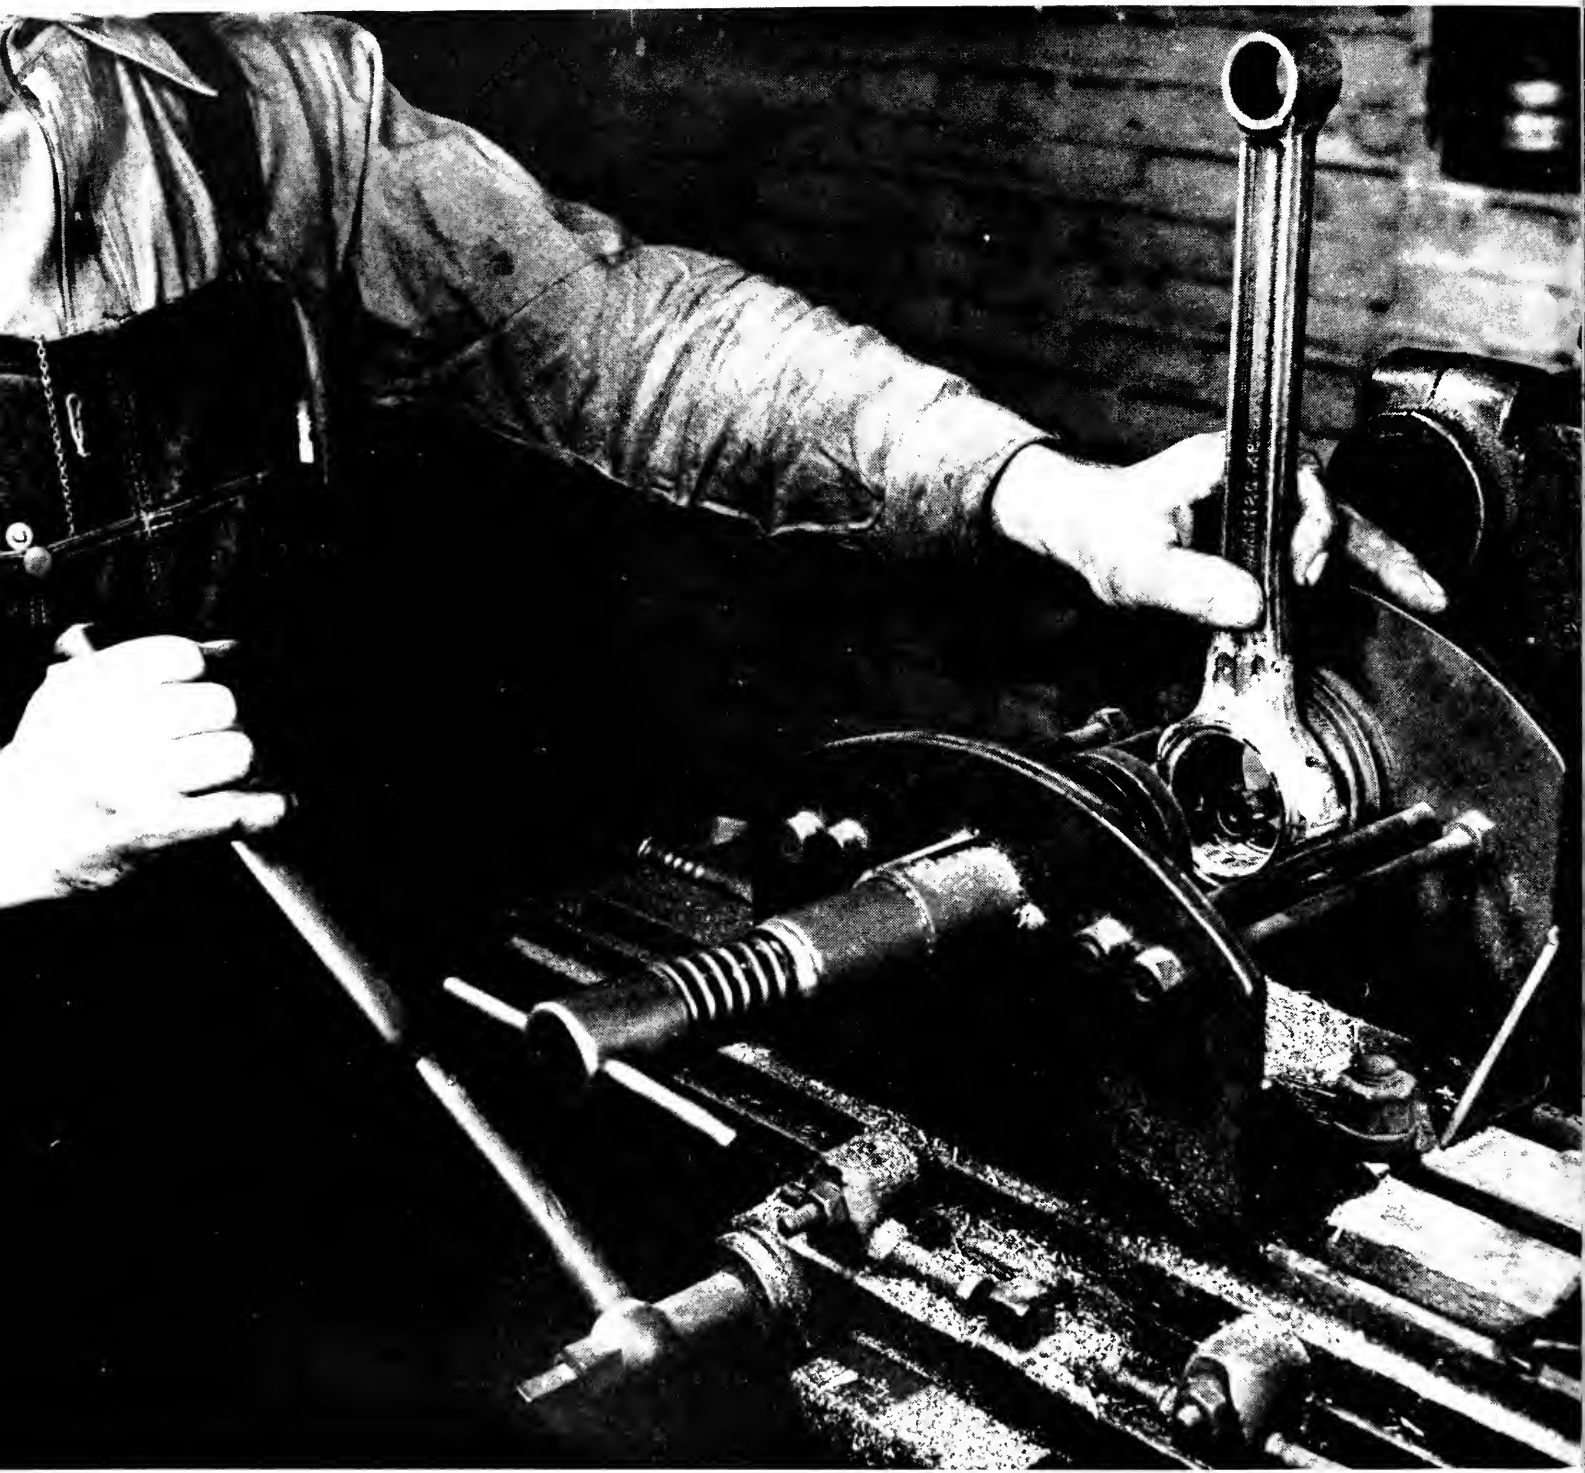
PLAINTIFF'S EXHIBIT No. 23

Approximately fifty per cent of the bearings have oil pockets which are cut by a hand milling machine as shown in the above picture.

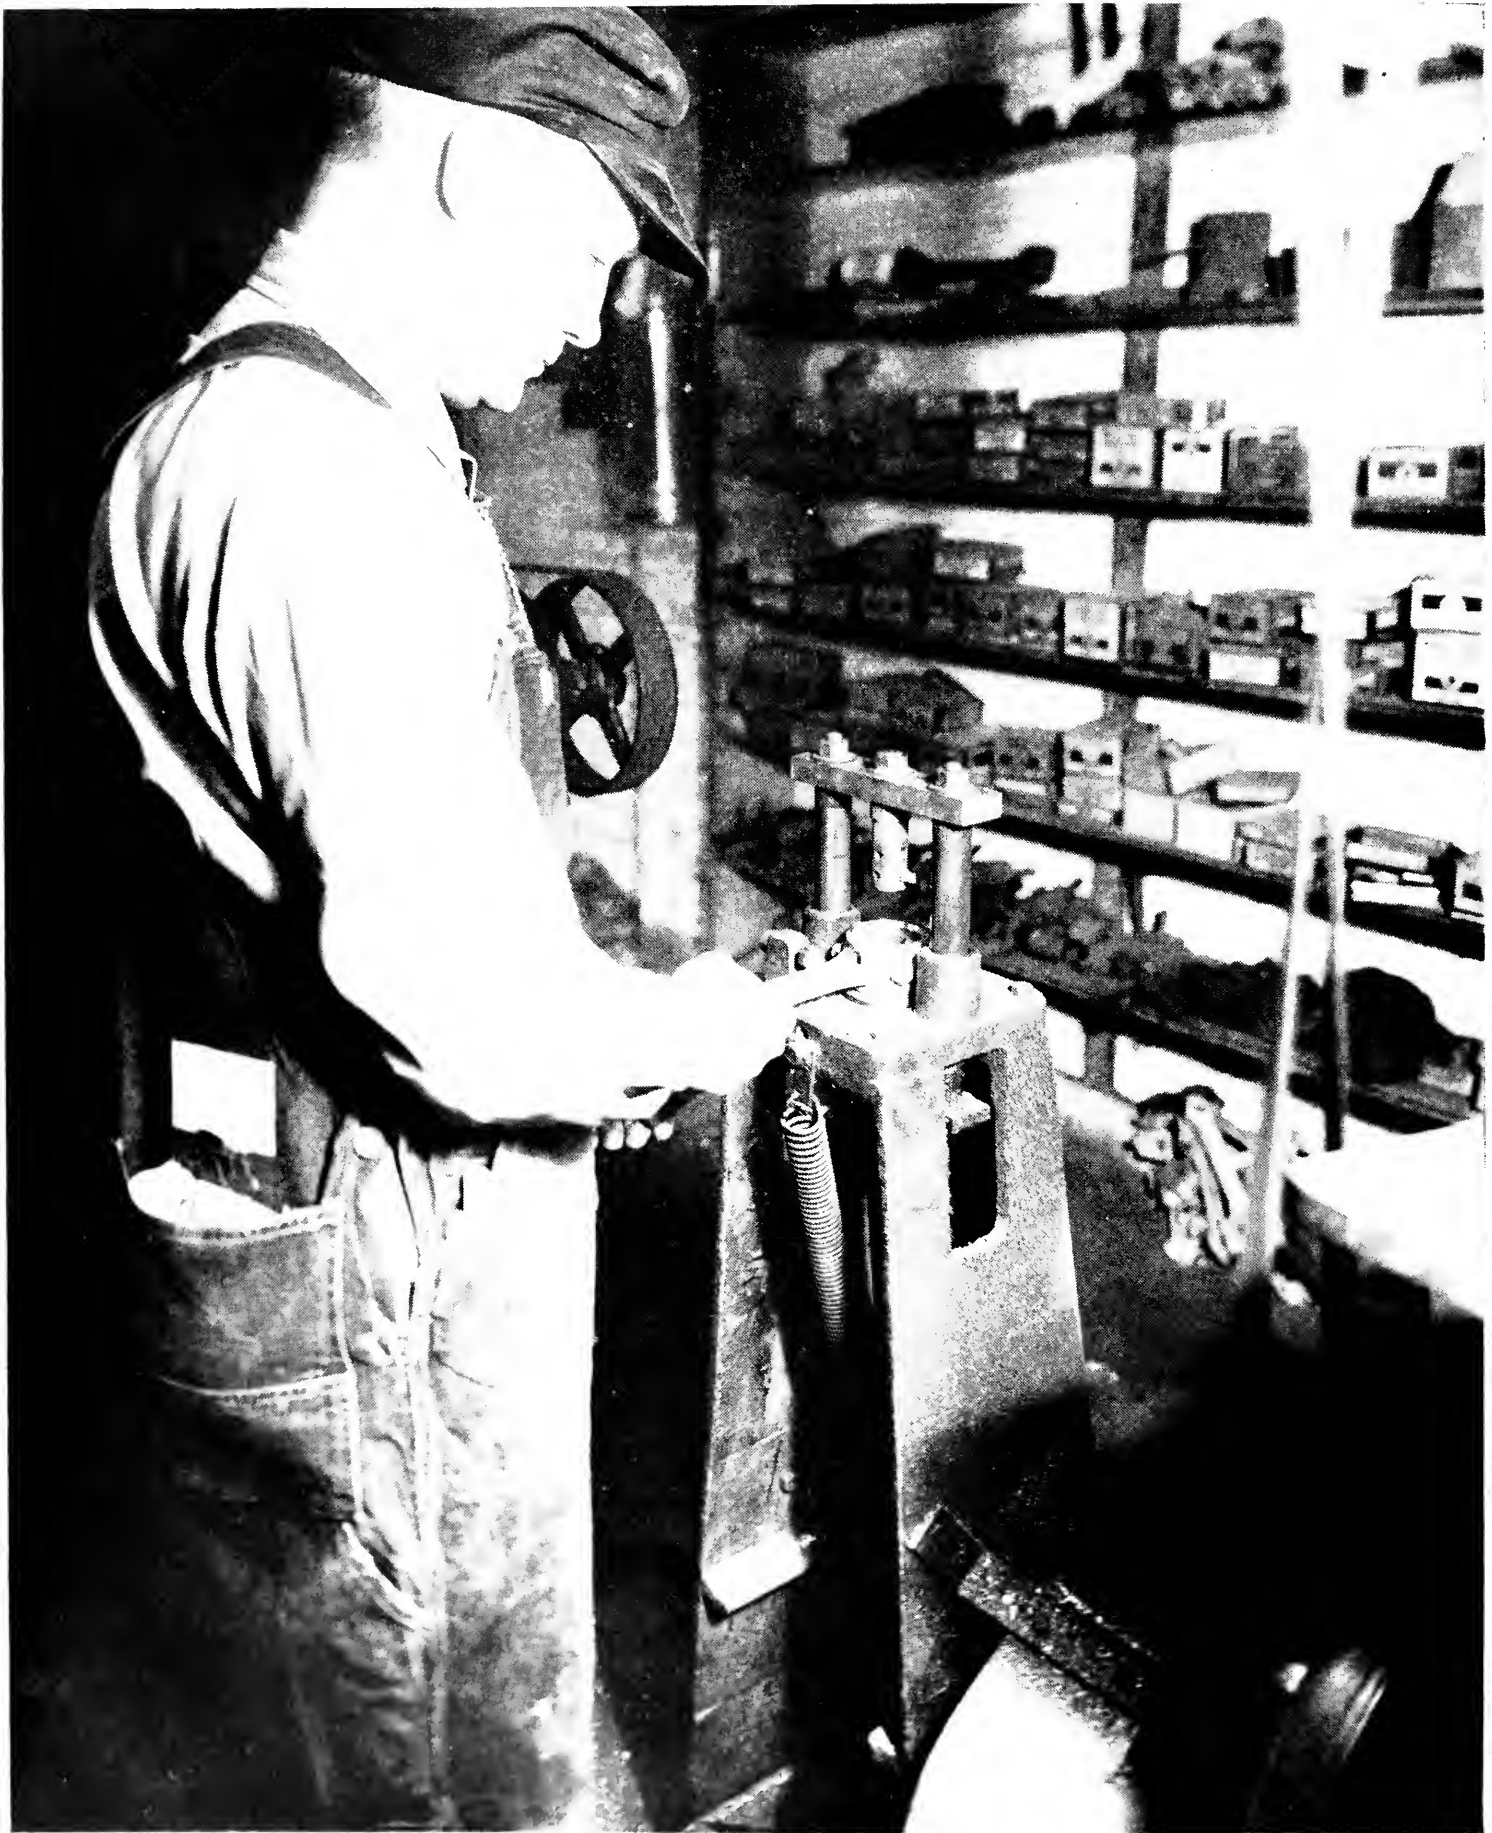
PLAINTIFF'S EXHIBIT No. 24

On Model A Ford connecting rods in which the babbitt was cast without the use of separator shims, it is necessary to cut the babbitt through the center of the bearing in order to free the cap from the shank. This operation also leaves an oil groove or relief which facilitates lubrication. This operation is performed by a slotting tool as shown in the above picture.

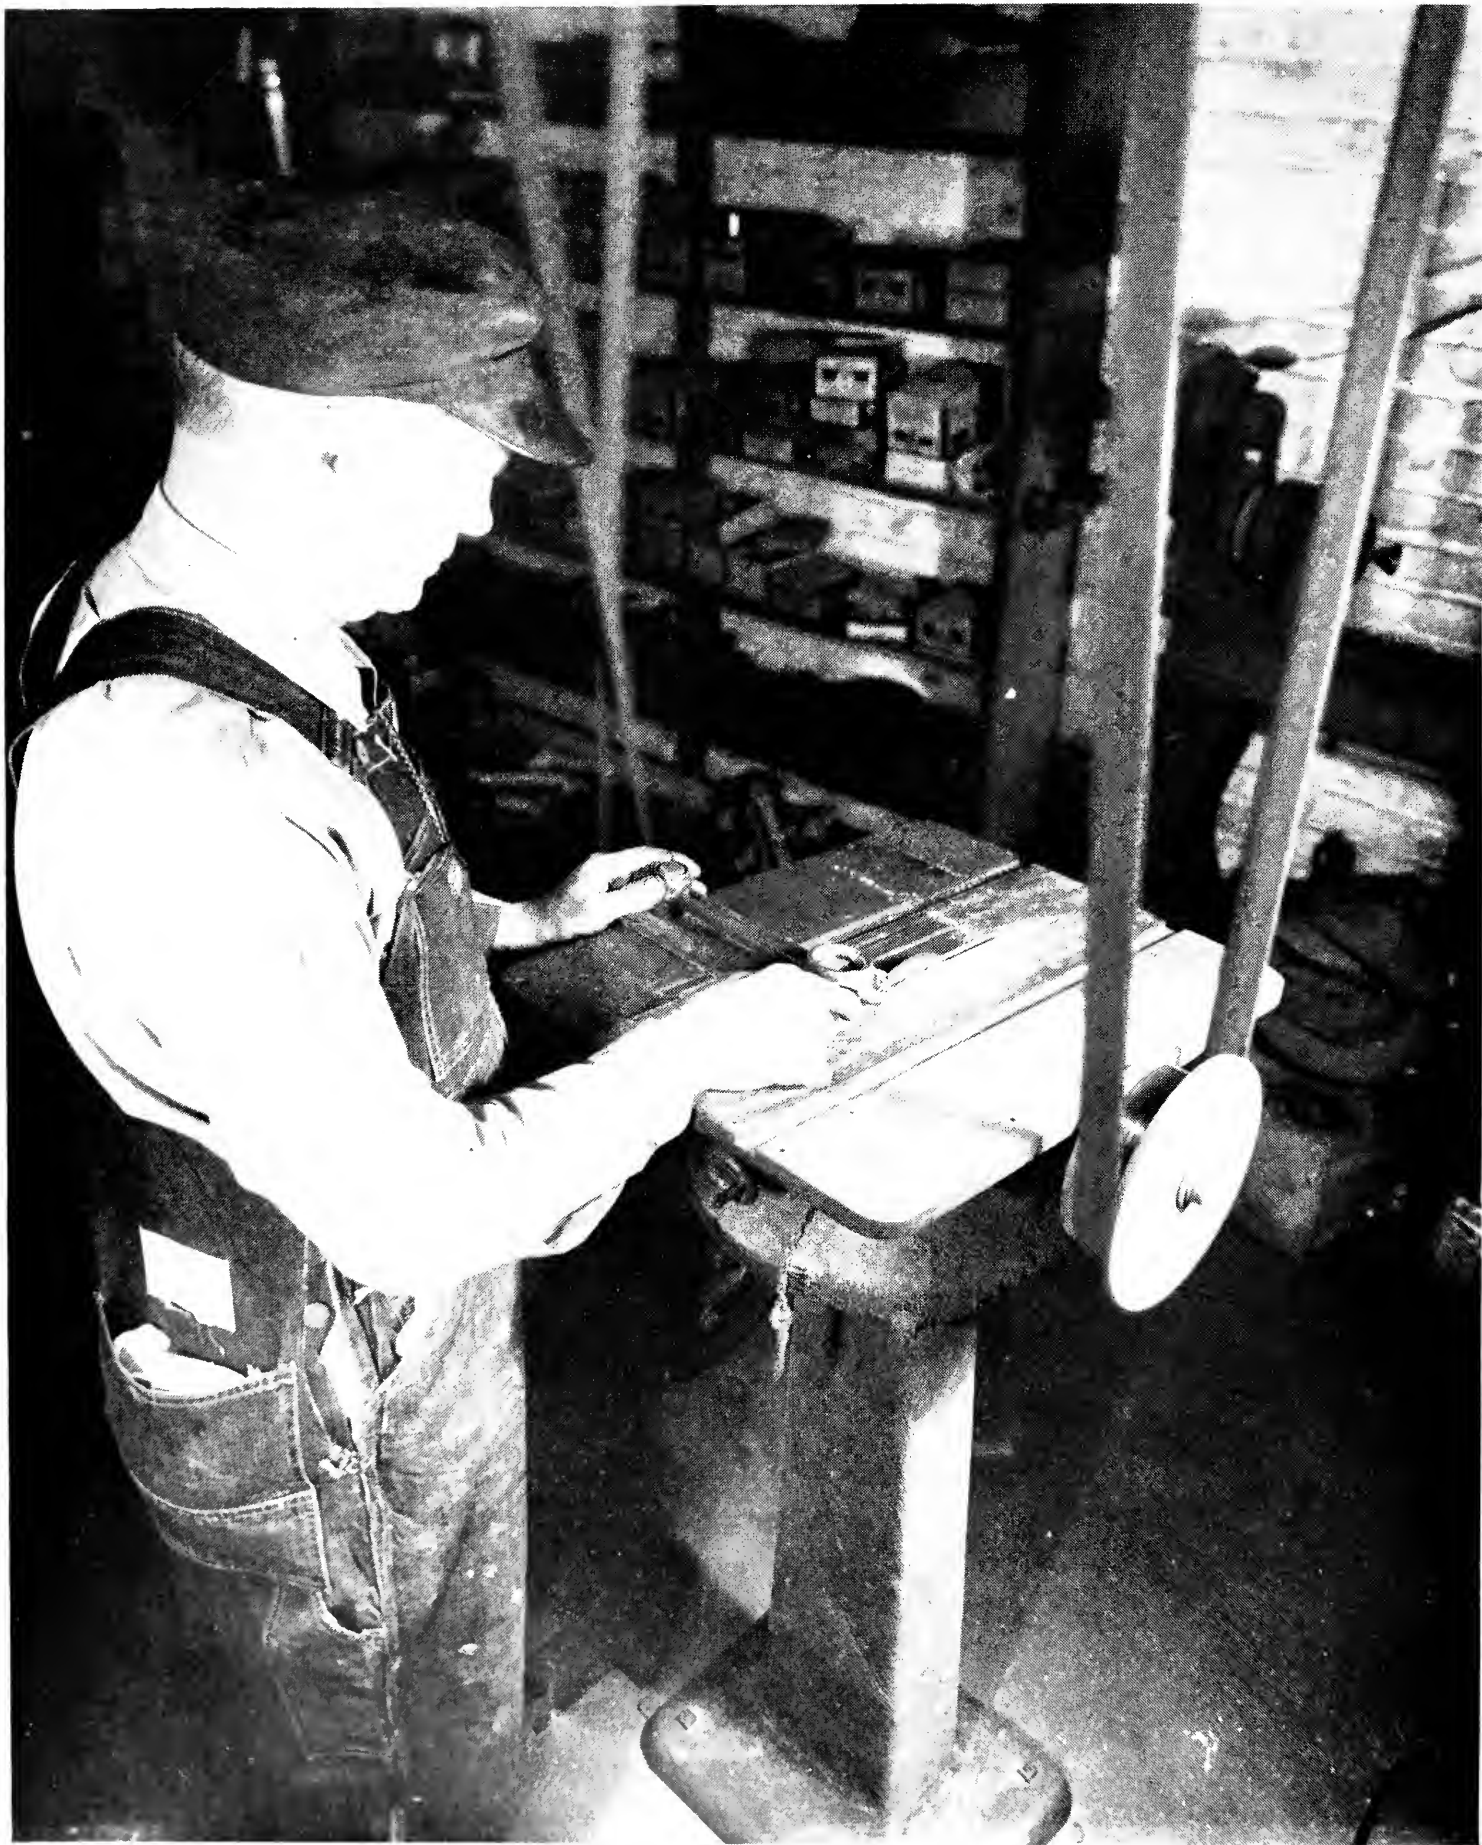
PLAINTIFF'S EXHIBIT No. 25

The Model A connecting rods are now on a saw table in which a rotating saw blade cuts the babbitt flange to complete the separating operation as shown in Picture 24. This also cuts the necessary oil relief groove through the flange.

The Model A connecting rods are now on a saw table in which a rotating saw blade cuts the babbitt flange to complete the separating operation as shown in Picture 24. This also cuts the necessary oil relief groove through the flange.
